Paris Branch
Recreational Use Attainability Analysis

March 2005

Prepared by:
MEC WATER RESOURCES, INC.
1000 North College Avenue, Suite 4
Columbia, Missouri 65201

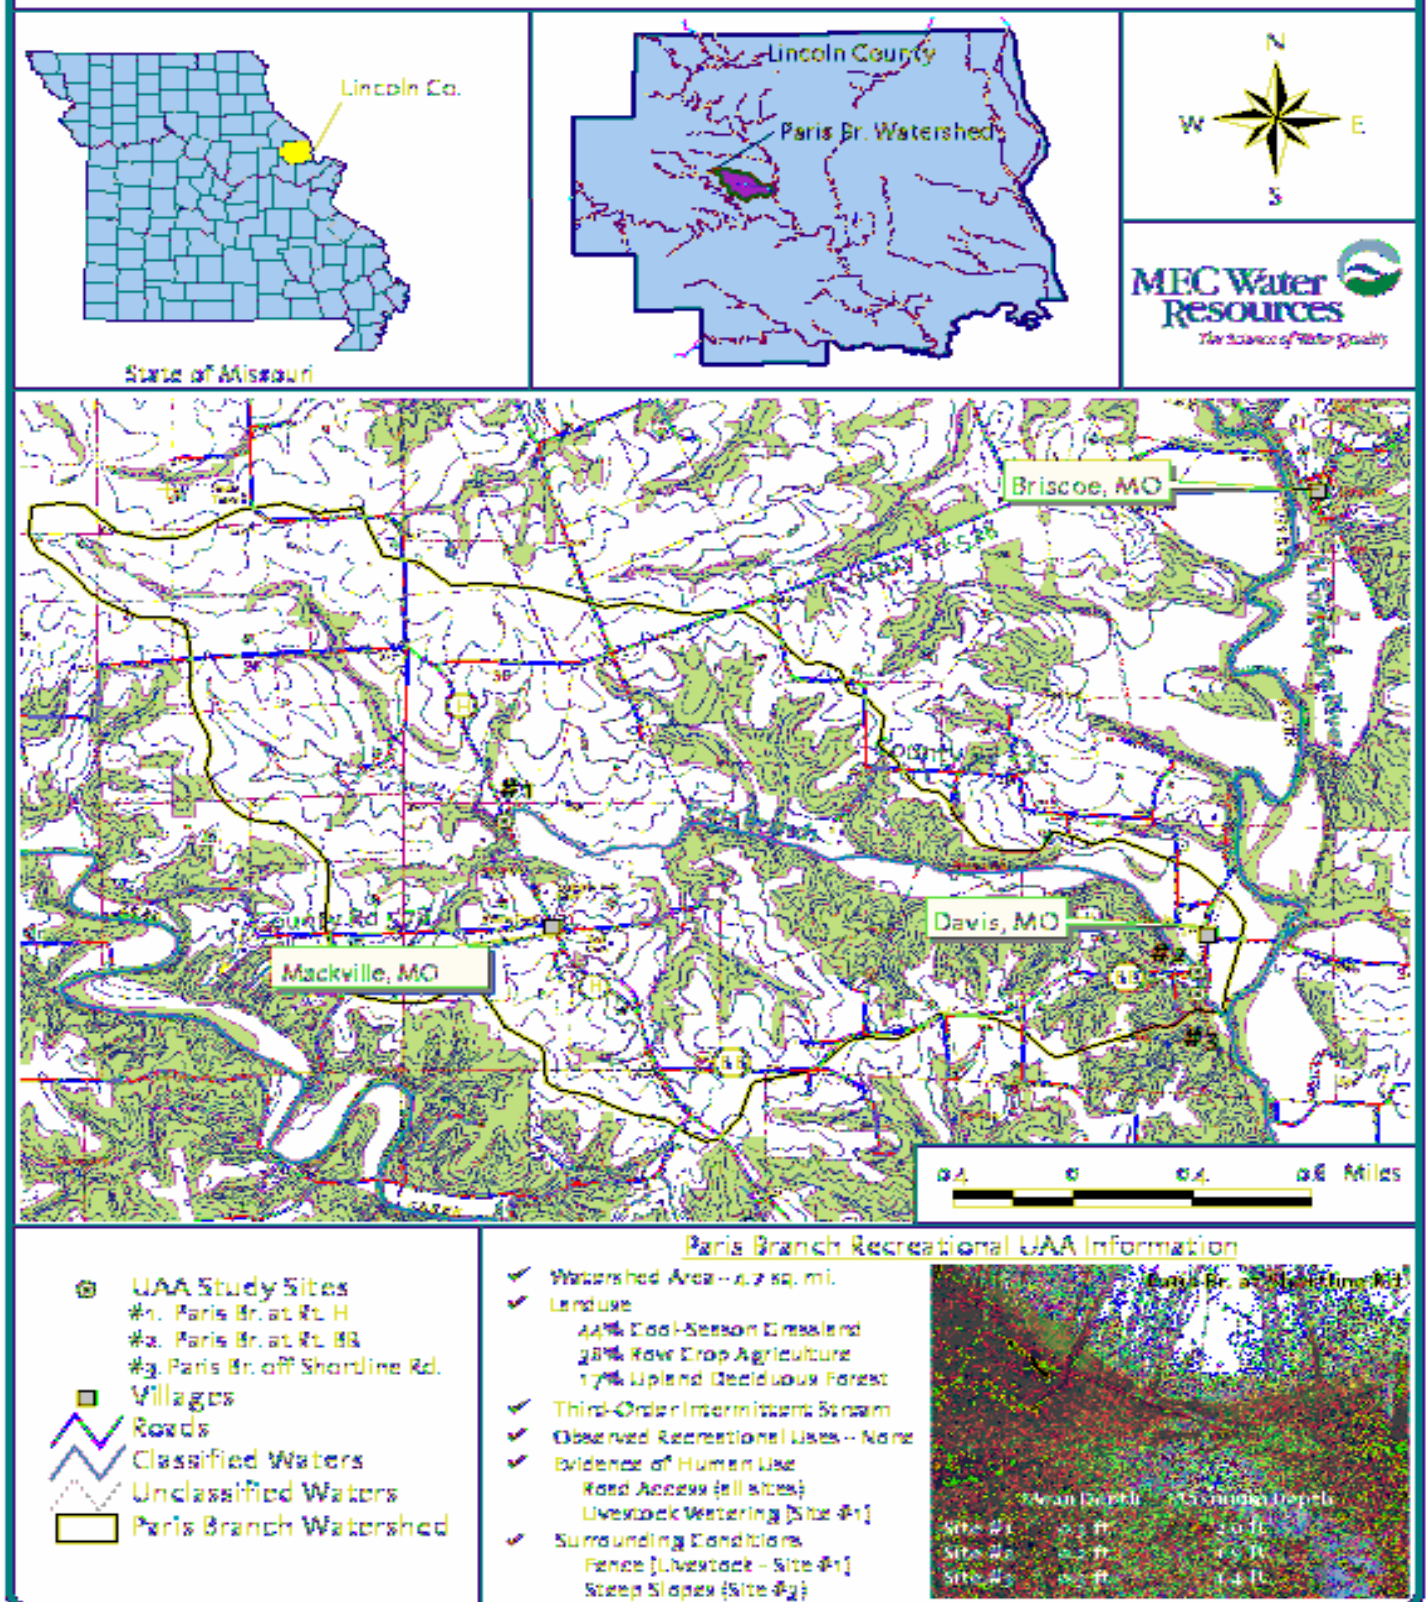
Figure 1. Paris Branch UAA Study Area and Sites

Three sites (Figure 1) within classified sections of Paris Branch were assessed on October 25, 2004 using methods described in section IV; Route H bridge (39.0672, -91.06424), Route BB bridge (39.0556, -91.02025), and the Shortline Road access (39.0545, -91.0197). Surveys were conducted during baseflow conditions as evidenced by precipitation data from USGS gage station 05514500 Cuivre River near Troy, MO and streamflow measurements taken in Paris Branch the day of the survey (Tables 1 & 2). Hydrologic conditions observed during the survey are believed representative due to a relatively small watershed area (4.7 mi.²) that limits periods of sustained baseflow, and the definition of Class C waters provided in State regulations.

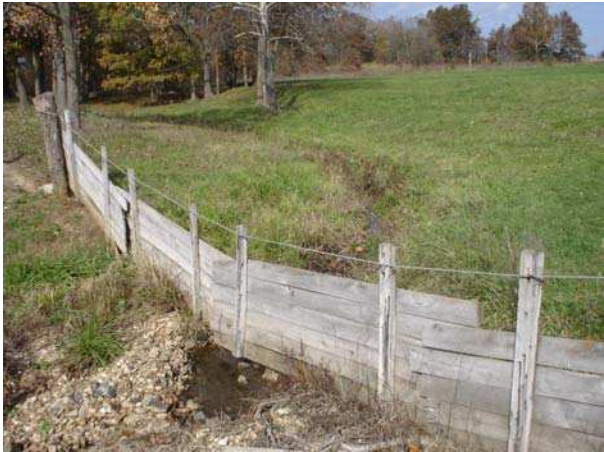
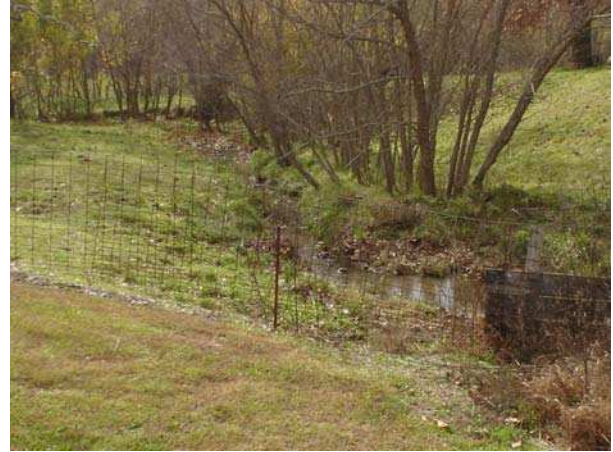
Figure 2. Paris Br. at Rt. H (Downstream View) Figure 3. Paris Br. at Rt. H (Upstream View)

The landscape near the Highway H bridge crossing is an open grazing pasture with a fence (Figure 2) across the stream channel. Livestock were observed grazing near the stream during the survey. Banks are gently sloping and are vegetated with grasses and forbs (Figure 3). Riparian areas are composed of cool-season grasses associated with the grazing pasture. Channel substrate was a mud and clay mixture. Limited algae deposits within pooled reaches may deter human use.

Mean depth along a 120 ft. assessment reach was 0.3 ft as determined from fifteen transects (Appendix B). The maximum depth observed at this location was 2.0 feet in a small pool upstream of the road access. There was no visible flow within the stream channel.

Livestock watering was the only observed or evidenced human use at this site. Fences impede public access to much of the assessment reach. No individuals were seen or found to be available for interviews near the Route H bridge during the survey.

MEC staff believe that Whole Body Contact Recreation (WBCR) is neither an existing or an attainable use at this site based on limited access to the stream imposed by fences, absence of observed recreational uses, and low flow shallow conditions.

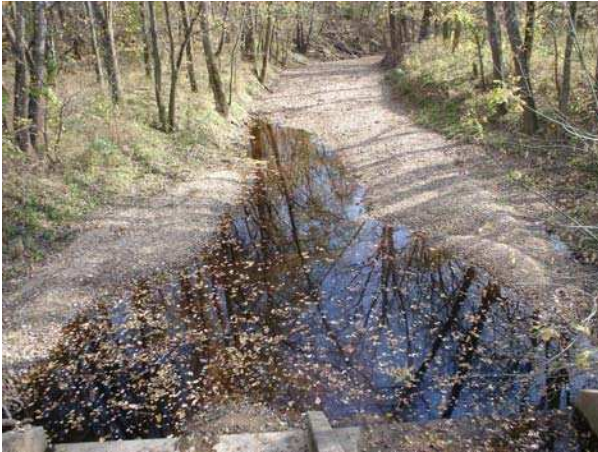
Figure 4. Paris Br. at Rt. BB (Downstream View)

The road crossing at Route BB is located near the small village of Davis, MO. Stream banks near the road are gently sloping and relatively easy to access (Figures 4 & 5). Riparian areas are wide and open and primarily vegetated by the upland deciduous forest complex. The stream channel was observed to be a mixture of cobble and sand. Mean depth along a 600 ft. assessment reach was 0.2 ft as determined from eight transects (Appendix B). The maximum depth observed at this location was 1.9 feet in a small pool downstream of the road access. There was no visible flow within the stream channel.

There were no observed or evidenced human uses at this site. No individuals were seen or found to be available for interviews near the Route BB bridge or the village of Davis during the survey. MEC staff believe that WBCR is neither an existing or an attainable use at this site based on absence of observed recreational uses and low flow shallow conditions.

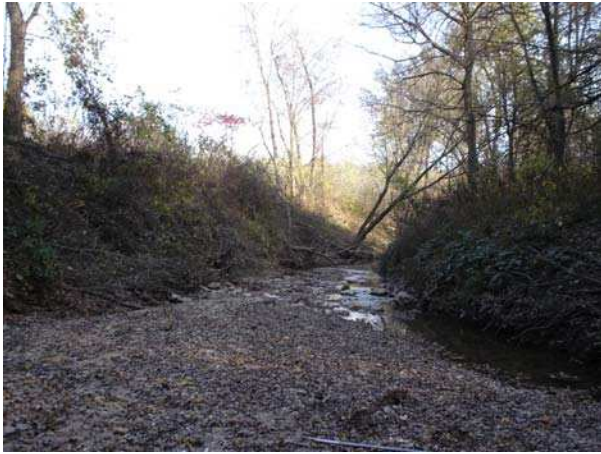
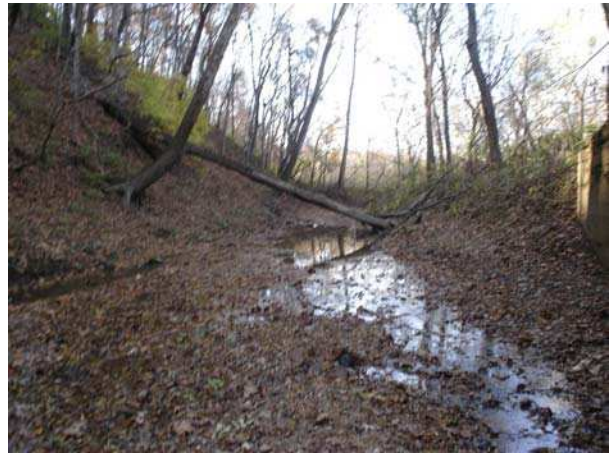
Figure 6. Paris Br. at Shortline (Downstream View) Figure 7. Paris Br. at Shortline (Upstream View)

Shortline Road is a small gravel road off Route BB that leads up to a private drive near the confluence of Paris branch and the North Fork Cuivre River. Stream banks are steep, sparsely vegetated, and covered with rocks and brush (Figures 6 & 7). Riparian area is greater than 100 feet wide on both sides of the stream and consists of large, mature trees. Stream substrate was approximately 80% cobble, 10% sand, and 10% silt.

Mean depth along a 500 ft. assessment reach was 0.3 ft as determined from seventeen transects (Appendix B). The maximum depth observed at this location was 1.4 feet in a small pool upstream of the road access. Observed streamflow was 0.42 cfs and a mean velocity of 0.38 fps.

There were no observed or evidenced human uses at this site. No individuals were seen or found to be available for interviews near the Shortline Rd. access during the survey. MEC staff believe that WBCR is neither an existing or an attainable use at this site based on absence of observed recreational uses and low flow shallow conditions.
